**BROWNELL DAM**  
NDS ID NO. 192  
**PENNSYLVANIA GAS AND WATER COMPANY**

**PHASE I INSPECTION REPORT**  
**NATIONAL DAM INSPECTION PROGRAM**

MAY 1978

SUSQUEHANNA RIVER BASIN,  
ROCKET BROOK, LACKAWANNA COUNTY,  
PENNSYLVANIA.

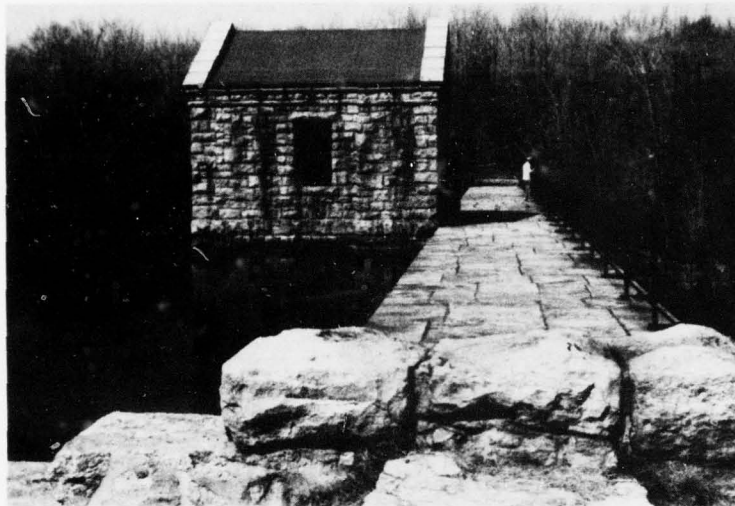
A. Masonry Gate Structure and Auxiliary Spillway

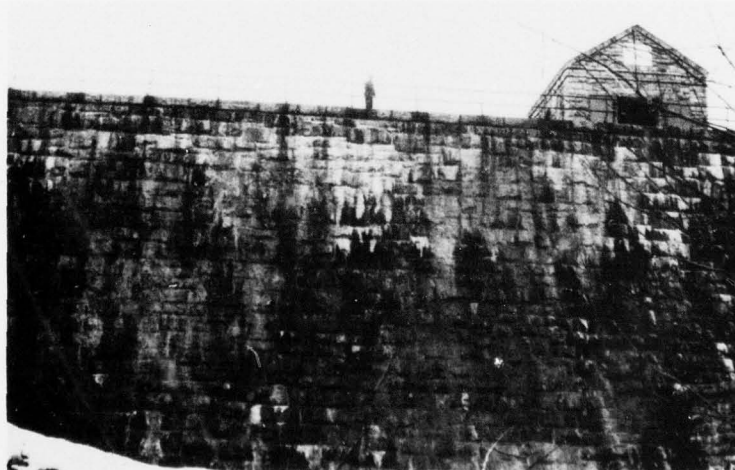
(1) The entire downstream face of the auxiliary spillway (Photograph B) is wet from about 6 feet below the crest. There are white powdery deposits, or efflorescence, over most of the face. The seepage was insufficient to cause flow at the toe

of the structure and was not localized in any particular areas. The mortar was in excellent condition. No cracks were observed. The handrail on the downstream side of the crest is corroded badly.

(1) The slight seepage on the downstream face of the auxiliary spillway is of slight concern at the present time. The cause of the calcium-like deposits on the face is unknown but they did not seem to be associated with any potential problems. The corroded handrail could be a hazard to personnel. It could also collect debris during flow over the auxiliary spillway and reduce the discharge.

B. Downstream Face of Auxiliary Spillway

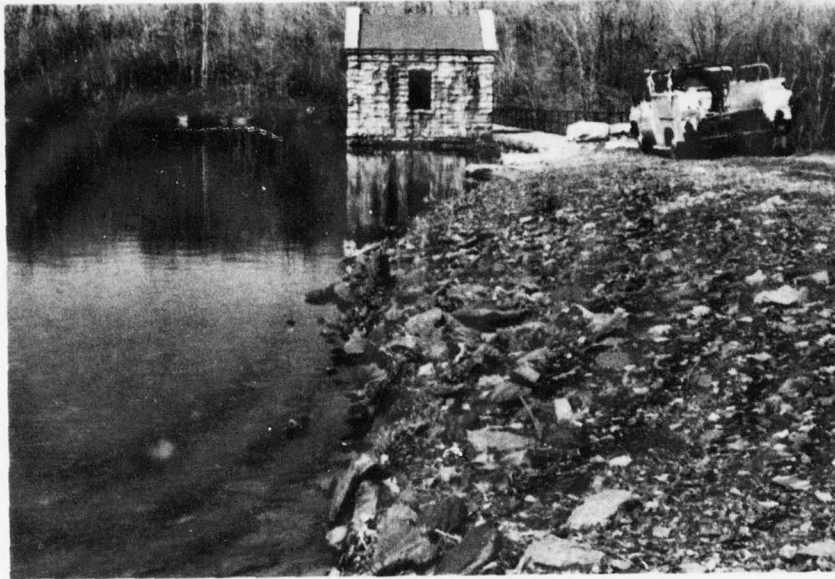
C. Masonry Gate Structure  
with Right Earth Embankment in Foreground

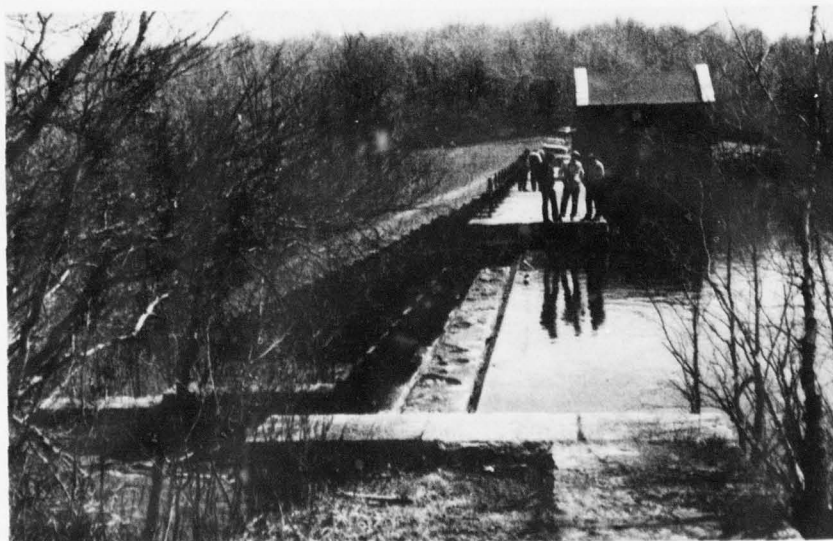
D. View from Left Abutment  
Main Spillway in Foreground

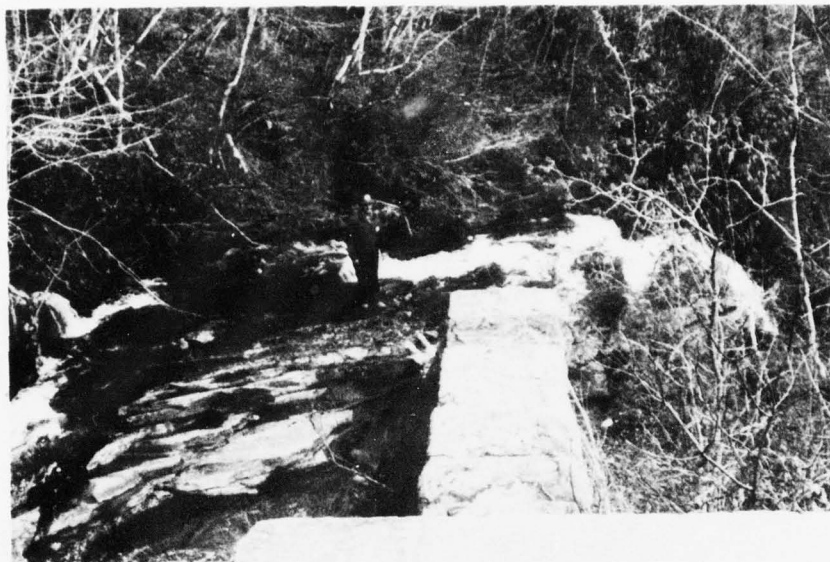
E. Downstream Channel of  
Main Spillway

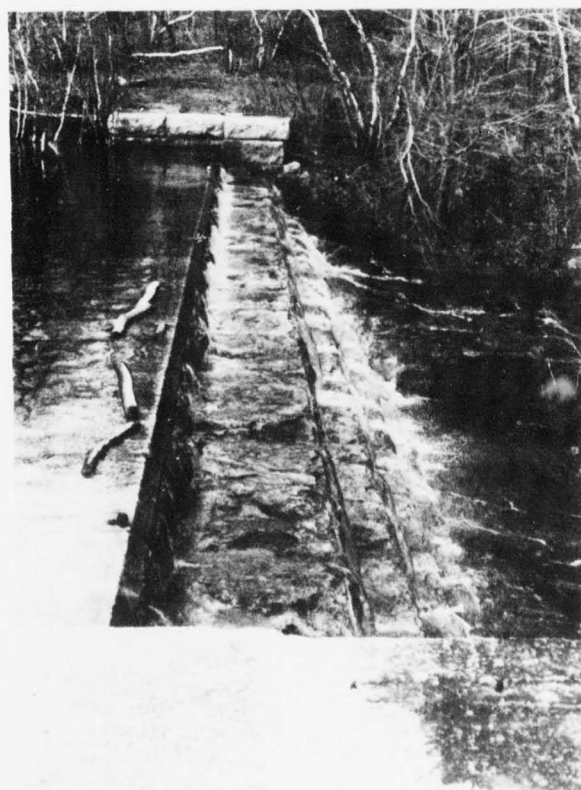
(2) The main spillway (Photograph F) appears to be in excellent condition. Water was flowing over the spillway during the inspection and detailed observations could not be made. However, the stones appeared to be in good condition. Where the spillway discharge turns right and drops over the natural rock ledge, there is evidence of some rock erosion at locations downstream of the right spillway wall. The upstream left and right retaining walls were submerged and therefore only the tops were visible below the water surface. The Owner has not reported any problems with these walls.

F. Main Spillway

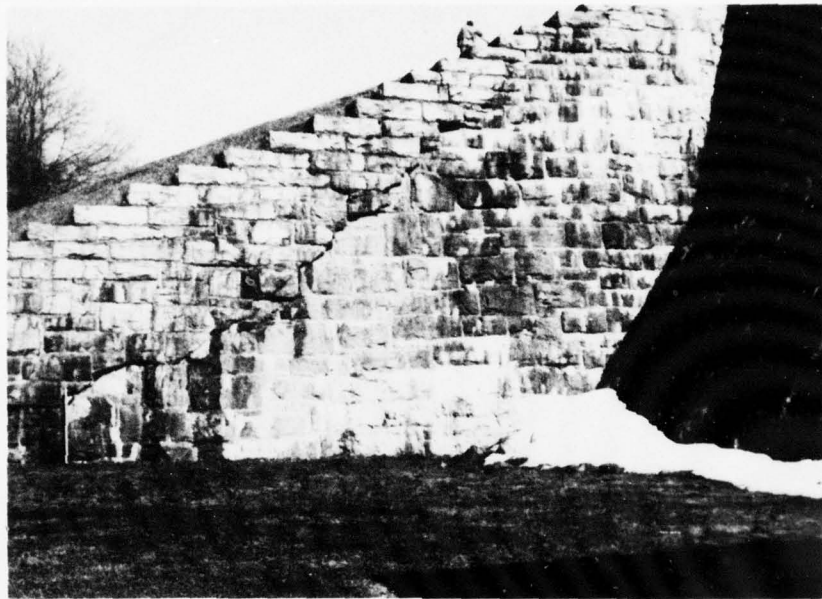
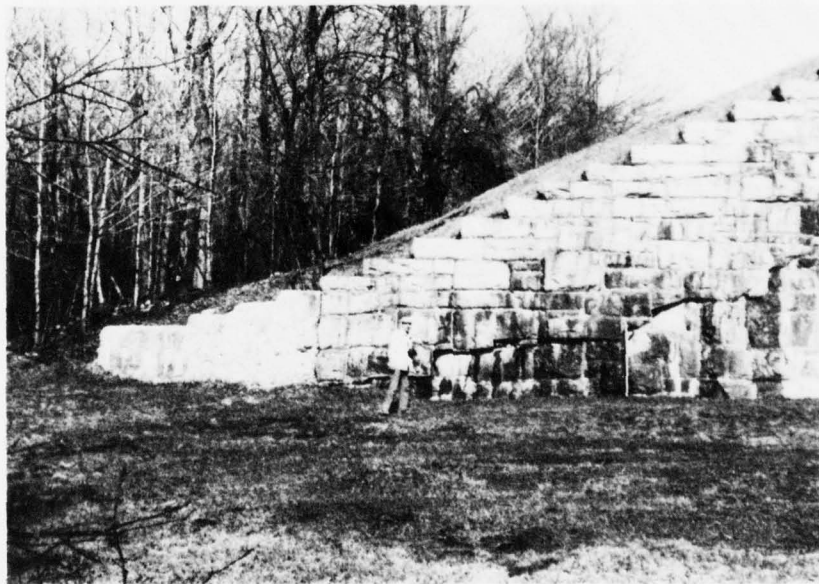
(3) The downstream auxiliary spillway right retaining wall (Photographs G and H) has a major structural crack extending from the bottom of the wall 16.5 feet from the downstream end to the top of the wall at the top of the embankment. The crack travels up at approximately a 30° angle with the horizontal and extends through the middle of some masonry blocks. The upper portion of the wall protrudes up to 0.7 foot beyond the lower portion. The face of the lower portion of the wall has a distinct batter while the face of the upper portion appears vertical. In plan, the top of the wall is bowed (Photograph I) with the middle of the wall about 2 feet out of line with the ends. Seepage is evident below this crack but is intermittent along the length. There is insufficient seepage to do more than wet the blocks. The downstream 15.5 feet of this wall is concrete (Photograph J) badly spalled at the edges and peeling over 80 percent of the face.

(3) Failure of the downstream auxiliary spillway right retaining wall could threaten the stability of the embankment. The Owner is aware of this problem and, as noted in Paragraph 2.4, has remedial measures prepared.

(2) Embankment. At the junction of the embankment at the right abutment and the auxiliary spillway right retaining wall, settlement of the embankment edge behind the wall has occurred. This settlement could be related to the observed crack and movement in the right abutment wall. A detailed description of the condition is in Paragraphs 3.1.b.(1) and 3.1.d.(3). A detailed evaluation of the condition is in Paragraphs 3.2.a.(1) and 3.2.c.(3).

The auxiliary spillway right retaining wall at the downstream side has a crack as previously discussed. The Owner has prepared plans and specifications to repair the wall. However, no definite schedule has been established for this repair work.

G. & H. Auxiliary Spillway Right Retaining Wall  
Showing Crack in Wall

(3) Implement the proposed repair program to the auxiliary spillway right retaining wall. As part of this program, install two or more observation wells, or other instrumentation, in the earthfill behind the retaining wall. Monitor instrumentation on a regular basis. If readings indicate potential problems, appropriate action should be taken.

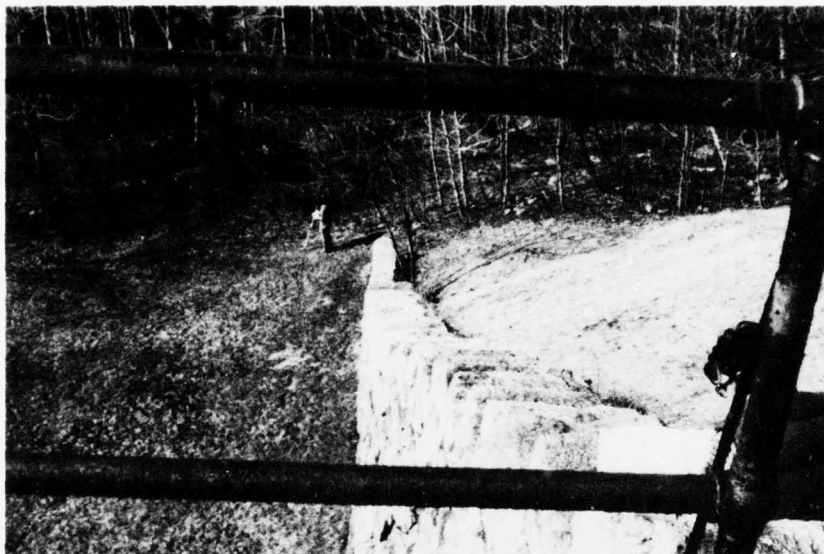
I. Auxiliary Spillway Right Retaining Wall  
Showing Bow in Wall

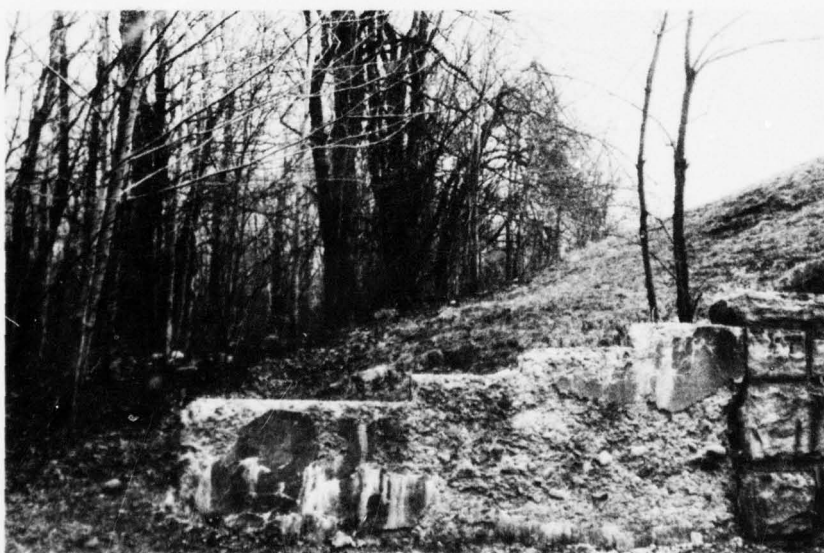
J. Downstream End of Auxiliary Spillway  
Right Retaining Wall

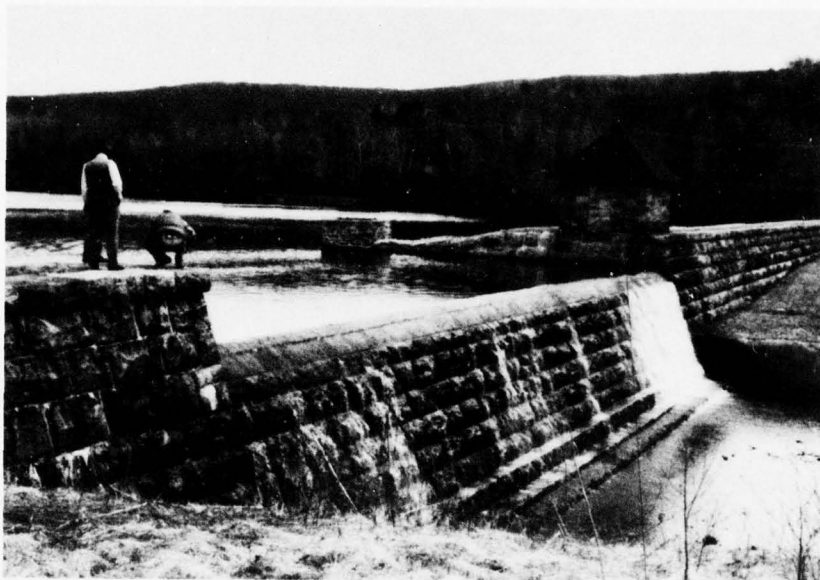
K. Carbondale Dam No. 4  
Upstream of Brownell Dam  
View from Right Abutment

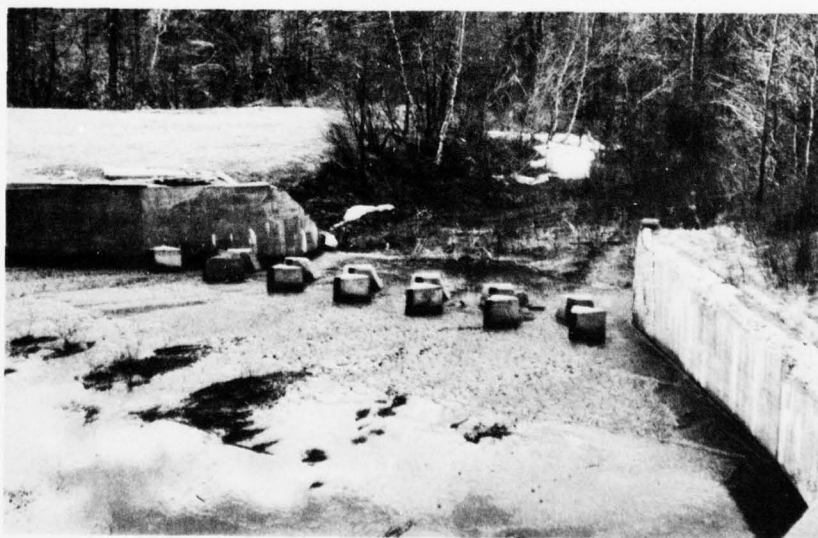
L. Carbondale Dam No. 4  
Upstream of Brownell Dam  
Spillway Channel Looking Downstream
